Death of an Airline: Aviation Safety Investigation

Keval Babu

Abstract

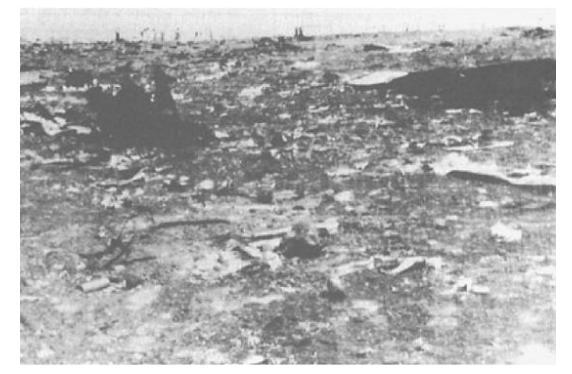
Figure 2: NationAir Flight 2120 Crash Site

During the downwind and base legs, the cabin floor above the wheel wells was consumed by fire, leading to cabin furnishing sagging into the wheel wells. Upon probable gear extension at 11 miles on final approach, the fire had compromised the seat harness, causing the first body to fall out. Subsequent structural destruction enabled further body and seat assembly losses. Despite significant airframe damage, the aircraft remained controllable.

At eight minutes post-brake release and ten miles from the runway, the captain declared an emergency for the third time, stating, "Nigeria 2120 declaring an emergency, we are on fire, we are on fire, we are returning to base immediately." The aircraft descended nose-down and impacted the ground 9,433 feet (2,875 meters) short of the runway at 08:38 [2].
